MUSCLE CAR REVIEW

DECEMBER 2007

PRESERVATION

Rust *Repair* Instead of *Replace*

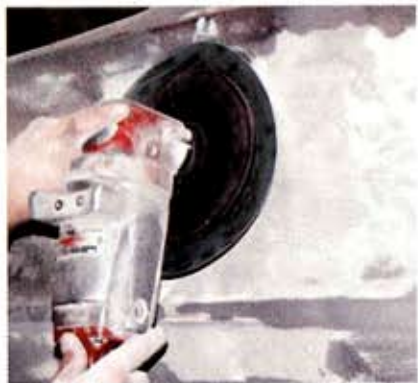
1 At first glance, the Nova's passenger-quarter's overabundance of filler suggests major dents and damage. Bill Jelinek of Rt. 66 Motorsports thought otherwise and set out to uncover the actual condition of the metal by buzzing the filler off the panel with an 8-inch grinder fitted with 3M 24-grit 9-inch discs.

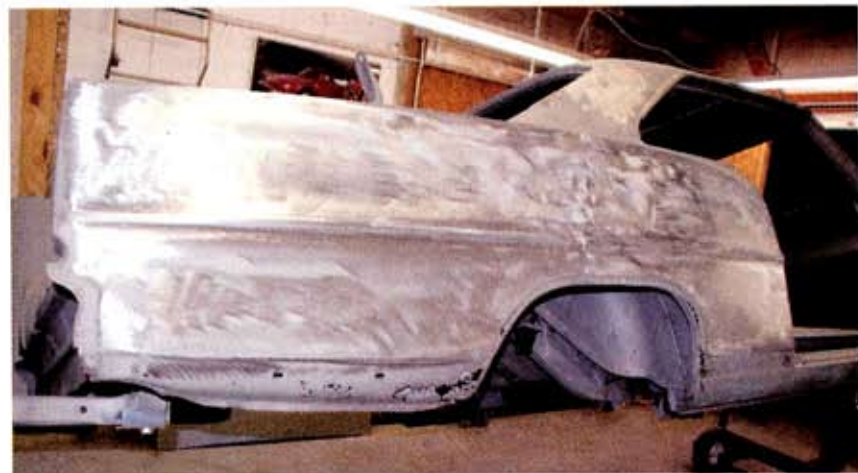
2 After the filler was removed, three trouble spots become evident: a fairly large, low area directly above the tire; a low spot near the Super Sport emblem location and a dent in the rearmost bottom corner of the quarter. The rust along the bottom of the quarter and wheelwell lip is minimal and can be easily repaired.

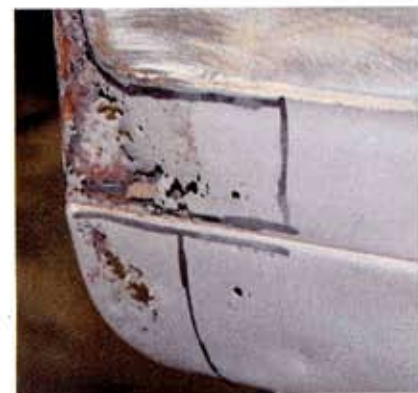
3 Cut lines are drawn on all cancerous areas. Jelinek was very conservative to remove the least amount of metal necessary.

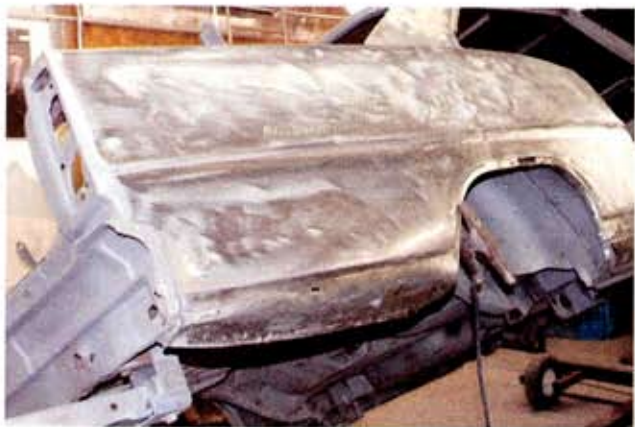
14 After Rock's efforts, the quarter-panel began to take shape, but it still needed repair on the wheel lip.

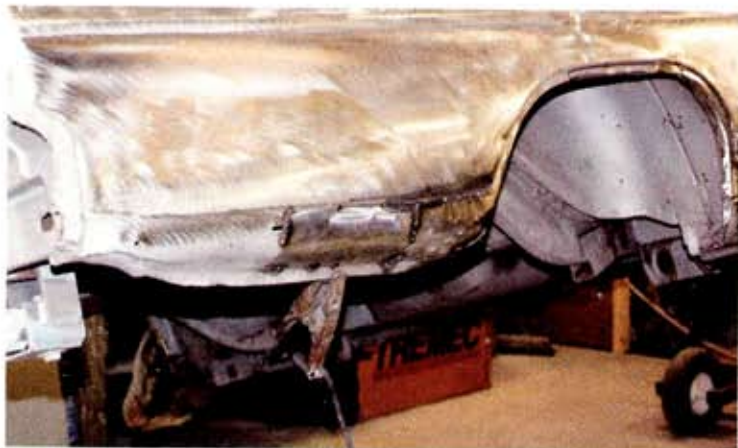
12 At this point, the dent at the rearmost bottom corner must be fixed.
