# L79

# BLASTING TIME

## Stripping a Nova Bare

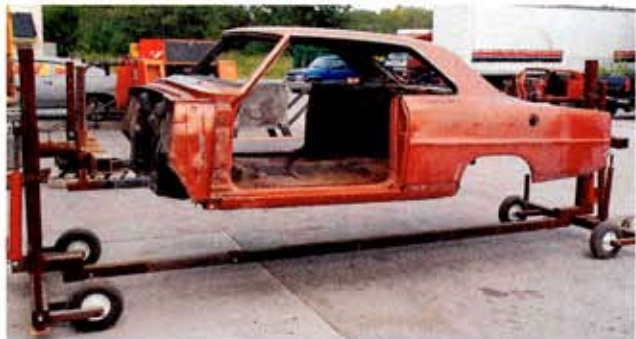
At Rt. 66 Motorsports, the Nova was mounted on a rotisserie in order to simplify the blasting process. The body and rotisserie were rolled onto a trailer and transported to Imperial Blasting in South Holland, Illinois.

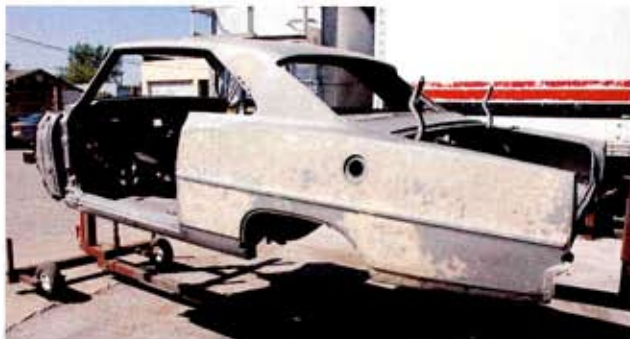
Here's how the car looked after blasting. The biggest surprise was the amount of body filler found on the flanks. Although relatively straight, the car's body has been worked quite extensively at some point in its life.

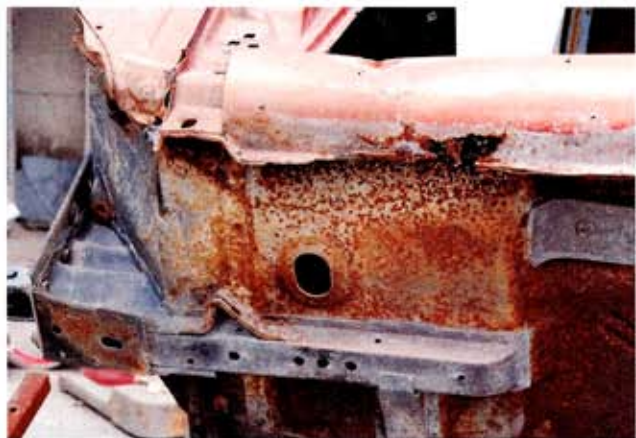
Possibly the biggest trouble spot on the car was at the cowl on the driver side, where it had been pushed in from a hit. Additionally, the rocker has rust that will need attention.

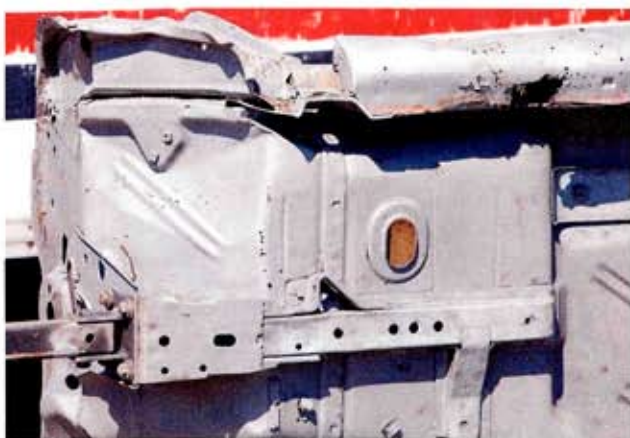
After blasting, the same area looked great in the framerail area and revealed minor pinhole rust in the driver-side floor pan and drain hole.

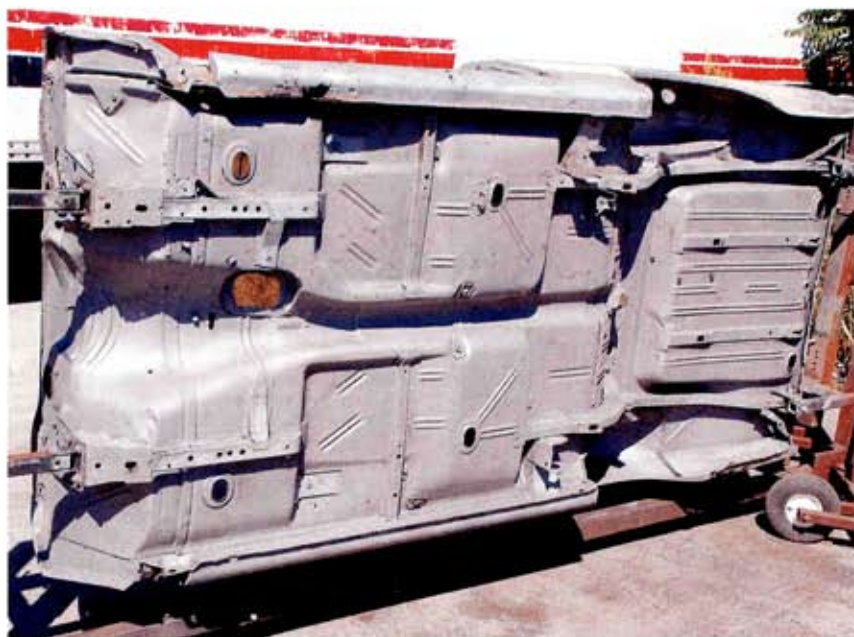
Before blasting, the body's floors and framerails looked fairly nice, with minimal rust. Cleaned up, the seams around the front framerails were especially nice. Although not pristine, the car clearly wasn't subjected to a lifetime of salt and grime.

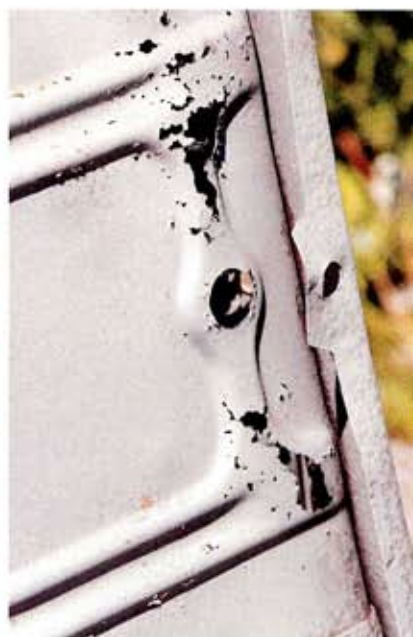
Looking at the underside of the trunk floor revealed rust near the latch area. Rt. 66 Motorsports' Bill Jelinek's repair plan for this car is to retain as much original metal as possible, so he'll put a small patch in this area.

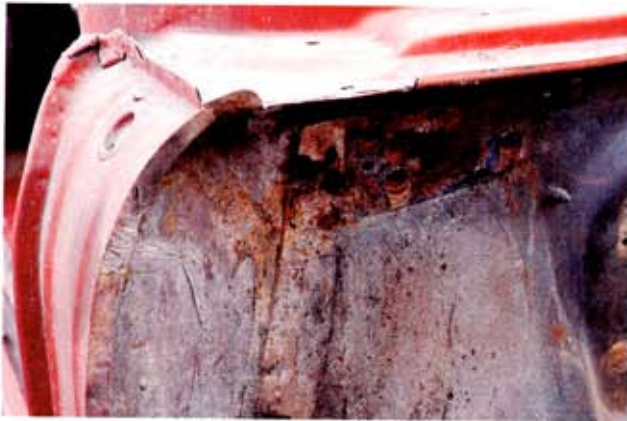
Trapped debris and moisture were certainly the culprits for the rust that affected this area where the front subassembly bolts to the cowl.

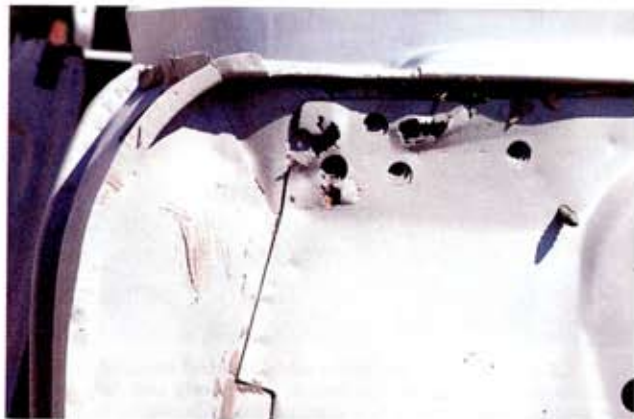
Blasting revealed the full extent of the damage. The repair must be accomplished while maintaining OE bracing and bolt-hole location.

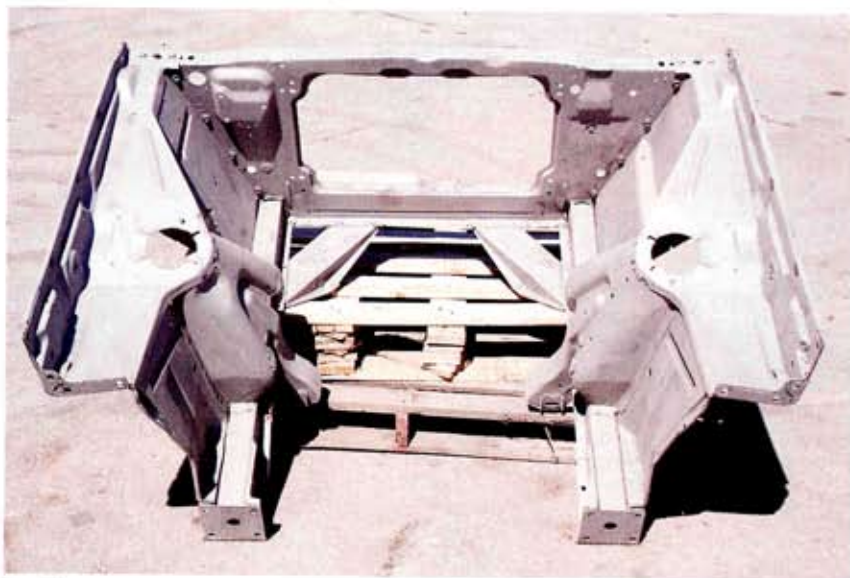
The front subassembly sourced from California returned from the booth in excellent shape.

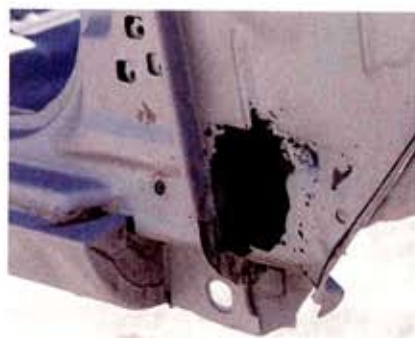
The bottom of the cowl on both sides was rusted through in this rust-prone area. Blasting made a very minimal change in the size of the hole, demonstrating the gentle impact that the IB Mineral has on the metal. Careful inspection will reveal how much metal has to be cut out and replaced.

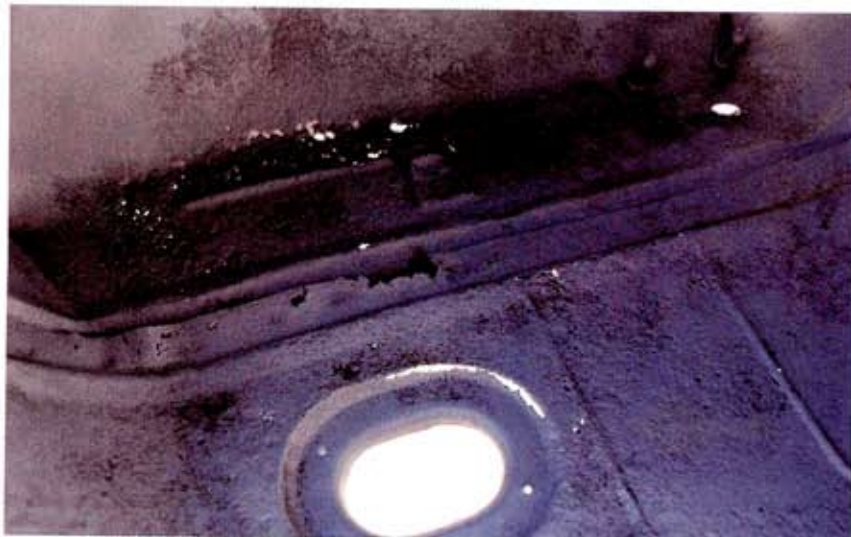
Prior to blasting, the floor seemed quite solid, with little evidence of rust damage. Afterwards, obvious pinholes were found in the driver-side floor and drain hole, requiring future work.

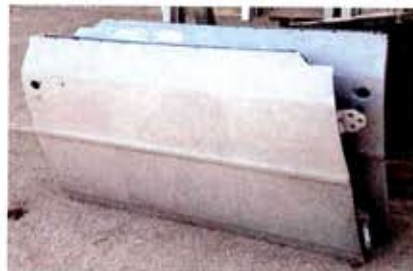
The original passenger-side door showed minimal rust in the front-bottom corner, while the driver-side \$50 "swap-meet-find" door returned rust-free. Overall, the L79 looked fine, and now, it's ready to go under the knife. *MCR*
